MEMORANDUM

SUBJECT: Site Assessment: Maline Creek Site, Bellefontaine Neighbors,

St. Louis County, Missouri

TDD: T07-9402-015 PAN: EMOO307SCA EPA/OSC: Don Hamera

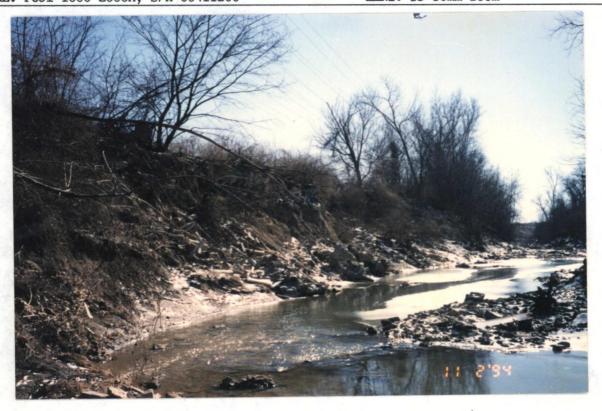
No: 1 Photographer: J. Parish Date/Time: 2/11/94/1115 Comments: Down Maline Creek from St. Cyr St. bridge Direction: SE

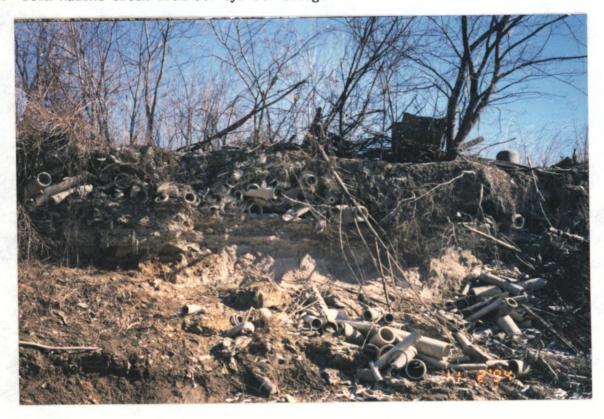
No: 2 Photographer: J. Parish Date/Time: 2/11/94/1116 Comments: East bank, 200 feet down from St. Cyr St. bridge Direction: E

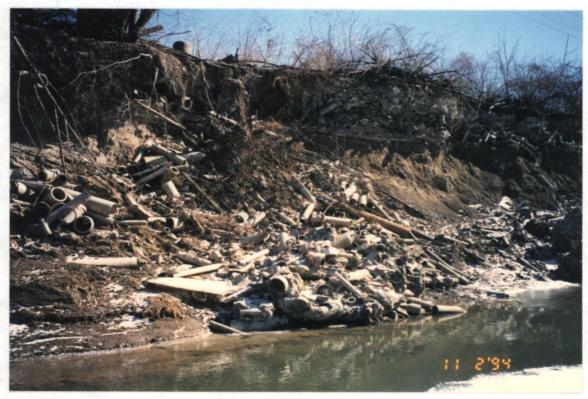
No: 3 Photographer: J. Parish Date/Time: 2/11/94/1120 Comments: Close view of east bank. Direction: E

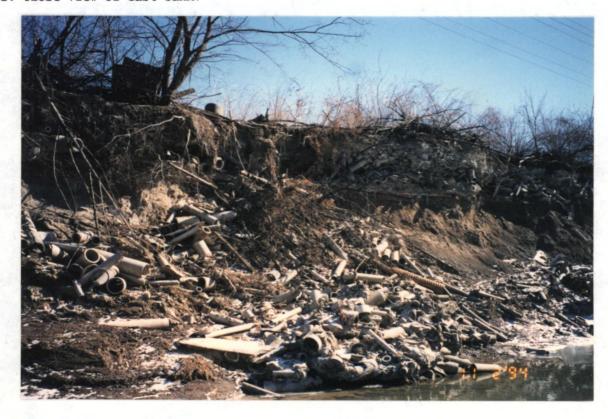
- o There had been a recent slumping of the creek bank, resulting in exposure of more transite pipe.
- o The creek bed was littered with more transite pipe than in previous investigations.
- o A portion of a fiber drum was exposed along the creek bank, suggesting that materials other than transite pipe may have been buried (refer to the photolog).

No: 4 Photographer: J. Parish Date/Time: 2/11/94/1121 Direction: E Comments: East bank cave-in

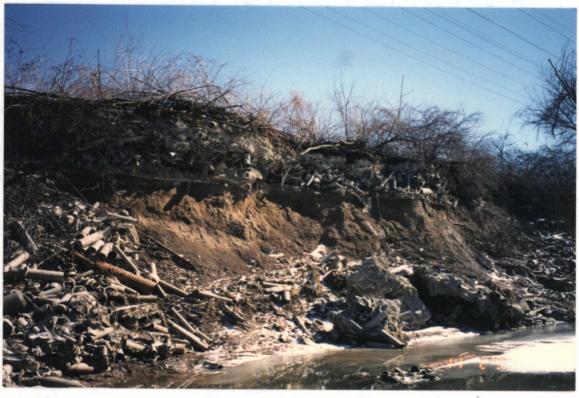
No: 5 Photographer: J. Parish Comments: East bank cave-in

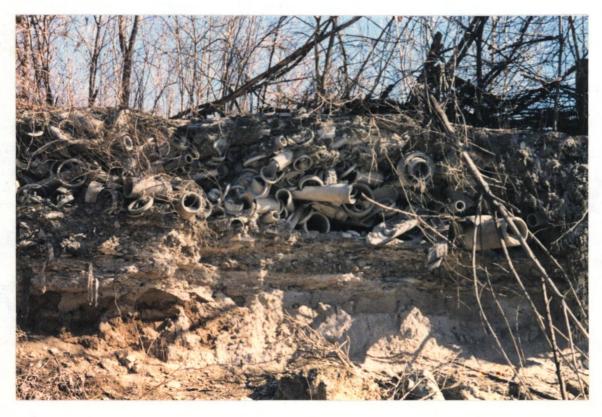
No: 6 Photographer: J. Parish Date/Time: 2/11/94/1124 Direction: E Comments: East bank, 100 yds from St. Cyr St. bridge

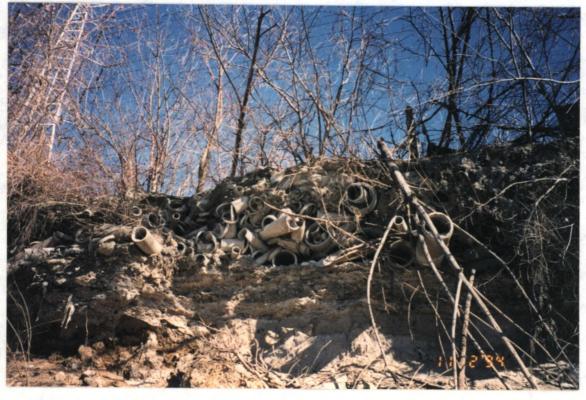
No: 7 Photographer: J. Parish Date/Time: 2/11/94/1125 Direction: E Comments: East cut bank

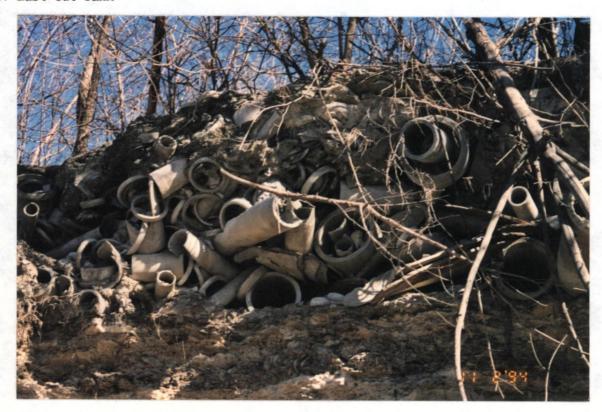
No: 8 Photographer: J. Parish Date/Time: 2/11/94/1125 Direction: E Comments: East cut bank, close view

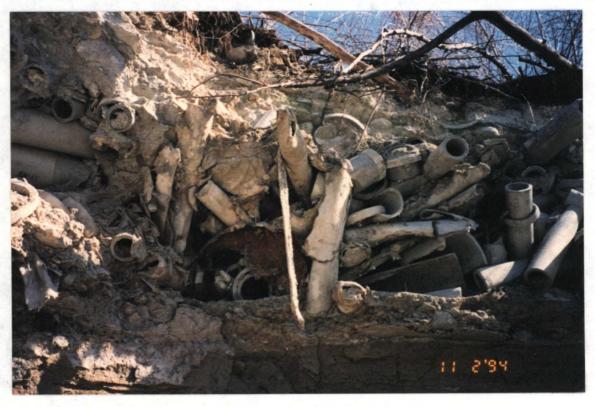
No: 9 Photographer: J. Parish Comments: East bank cave—in

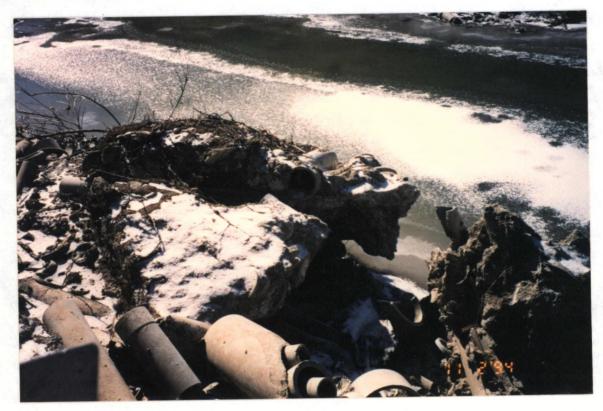
No: 10 Photographer: J. Parish Date/Time: 2/11/94/1128 Direction: W Comments: Cave-in material near creek

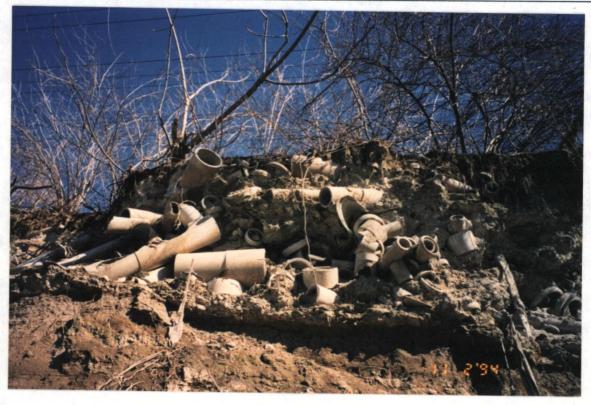
No: 11 Photographer: J. Parish Date/Time: 2/11/94/1130 Direction: E Comments: Cut bank, 100 yds from St. Cyr St. bridge

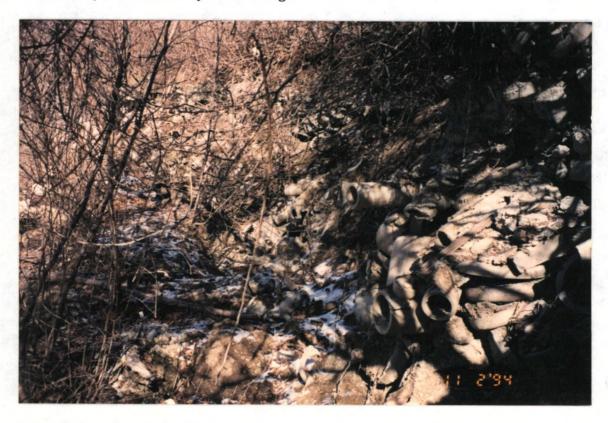
No: 12 Photographer: J. Parish Date/Time: 2/11/94/1133 Direction: N Comments: East bank slump, about 350 feet from St. Cyr St. bridge.

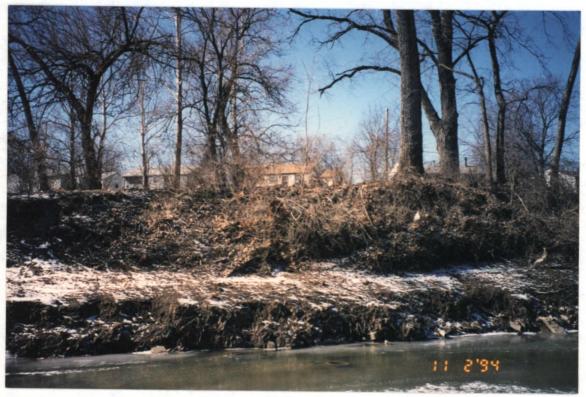
No: 13 Photographer: J. Parish Date/Time: 2/11/94/1134 Direction: W Comments: West bank across from exposed transite pipe, residence in background.

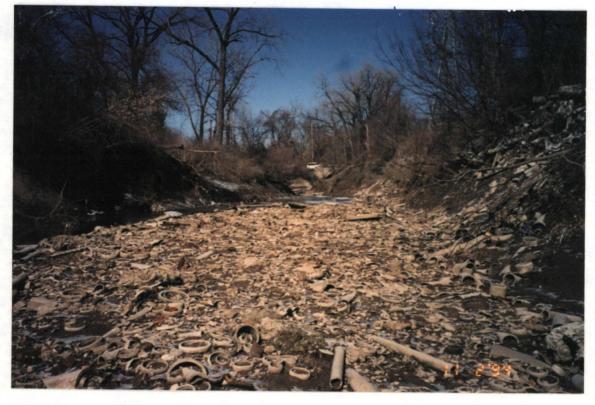
No: 14 Photographer: J. Parish Date/Time: 2/11/94/1138 Direction: N Comments: Transite in creek bed down 200 yards from St. Cyr St. bridge.

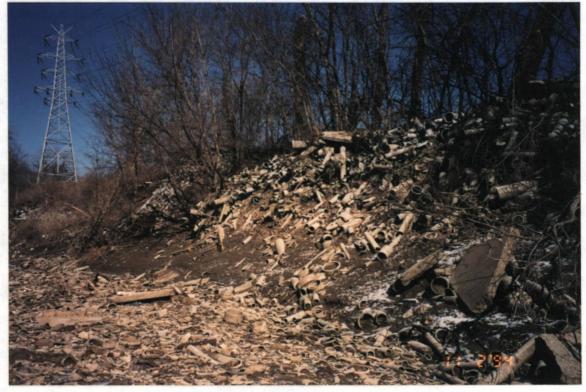
No: 15 Photographer: J. Parish Date/Time: 2/11/94/1140 Comments: East bank, 200 yards from St. Cyr St. bridge.

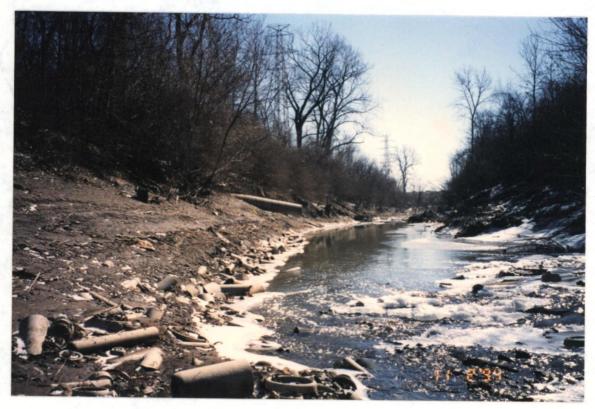
No: 16 Photographer: J. Parish Date/Time: 2/11/94/1141 Comments: Downstream, showing transite pipe in channel.

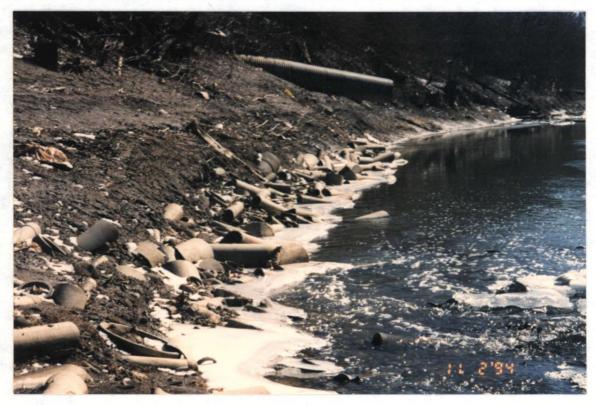
No: 17 Photographer: J. Parish Date/Time: 2/11/94/1141 Direction: SE Comments: close view of creek channel showing exposed transite pipe.

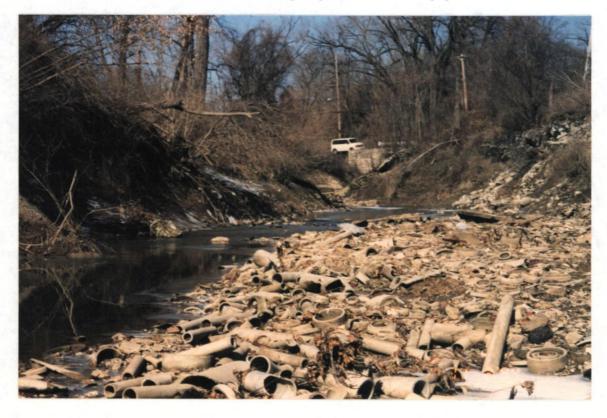
No: 18 Photographer: J. Parish Date/Time: 2/11/94/1145 Direction: N Comments: Close view, upstream, same location.

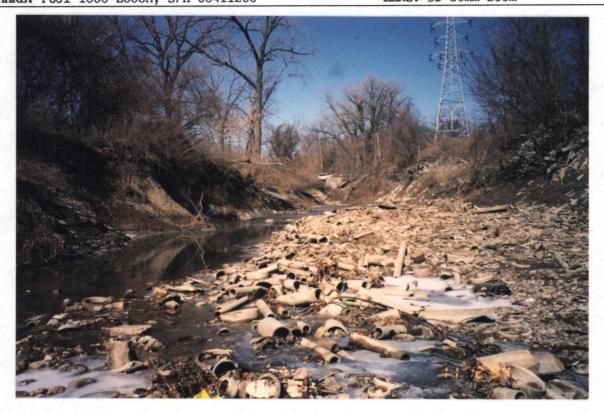
No: 19 Photographer: J. Parish Date/Time: 2/11/94/1145 Comments: Upstream, wide angle view, same location. Direction: N

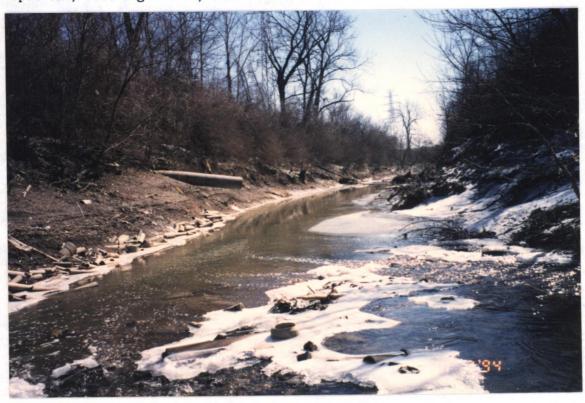
No: 20 Photographer: J. Parish Date/Time: 2/11/94/1146 Comments: Downstream wide angle view, same location. Direction: SE

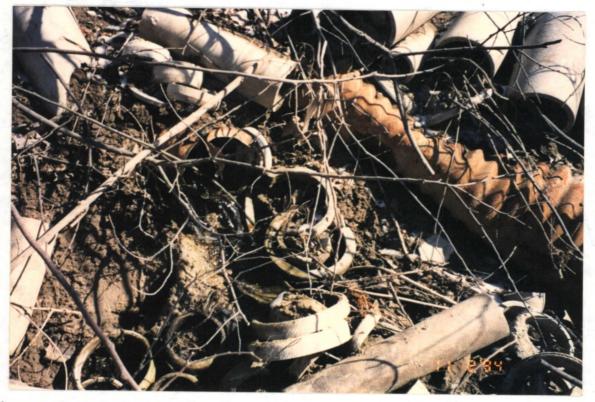
No: 21 Photographer: J. Parish Date/Time: 2/11/94/1155 Direction: E Comments: Conduit draining from east bank about 200 feet from St. Cyr St. bridge.

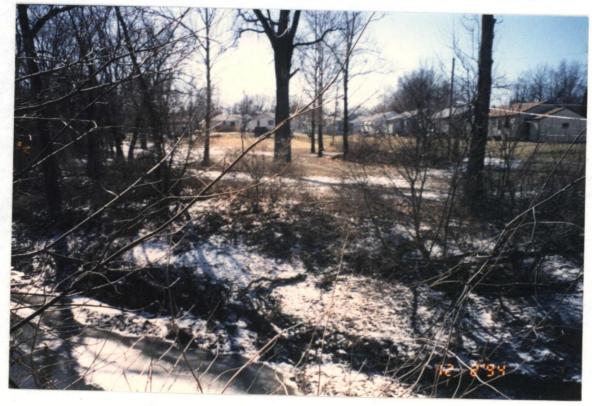
No: 22 Photographer: J. Parish Date/Time: 2/11/94/1203 Direction: SW Comments: Local residences across from exposed transite pipe

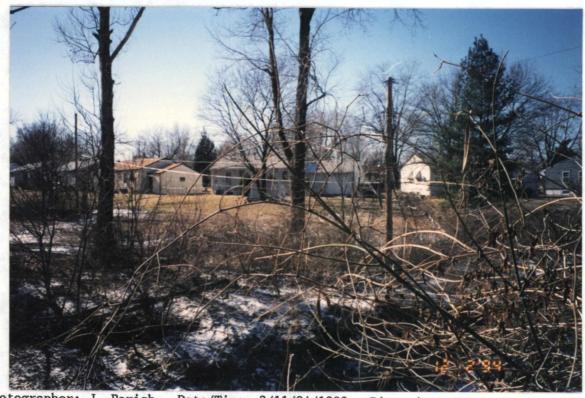
No: 23 Photographer: J. Parish Date/Time: 2/11/94/1203 Di Comments: Local residences across from exposed tarnsite pipe. Direction: SW

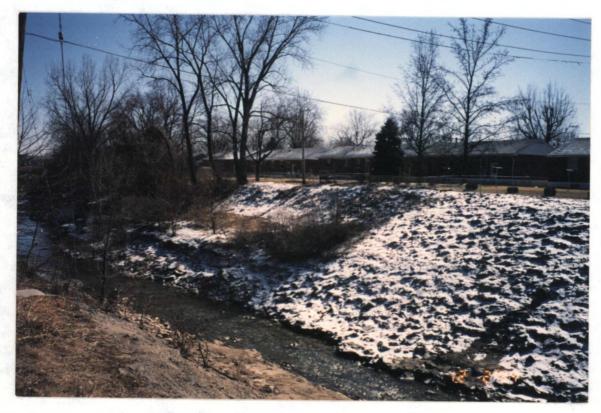
No: 24 Photographer: J. Parish Date/Time: 2/11/94/1207 Direction: SW Comments: Residences upstream near Bellefontaine Rd. Bridge and Maline Creek.
